# Final report

<b>Project title</b>	<b>New Coatings for Biomass Firing</b>
<b>Project identification</b>	14-I 64014-0109
<b>Name of the programme which has funded the project</b>	EUDP 14-I. Programme area: Biomass
<b>Project managing company/institution</b>	DTU Mekanik, Niels Koppels Allé 404, 2800 Kgs. Lyngby
<b>Project partners</b>	Added Values P/S Refa Energi A/S Verdo A/S Burmeister & Wain Energi A/S – replaced by BWSC A/S
<b>CVR</b> (central business register)	30060946
<b>Date for submission</b>	November 13, 2018

*The project aimed to develop and demonstrate new corrosion resistant coating materials for heat exchangers (superheaters) in biomass fired CHP plants. Very promising systematic laboratory results had indicated that coatings based on Al and/or Ni could to enable improved economy in biomass firing through increased reliability, prolonged lifetimes and higher efficiency.*

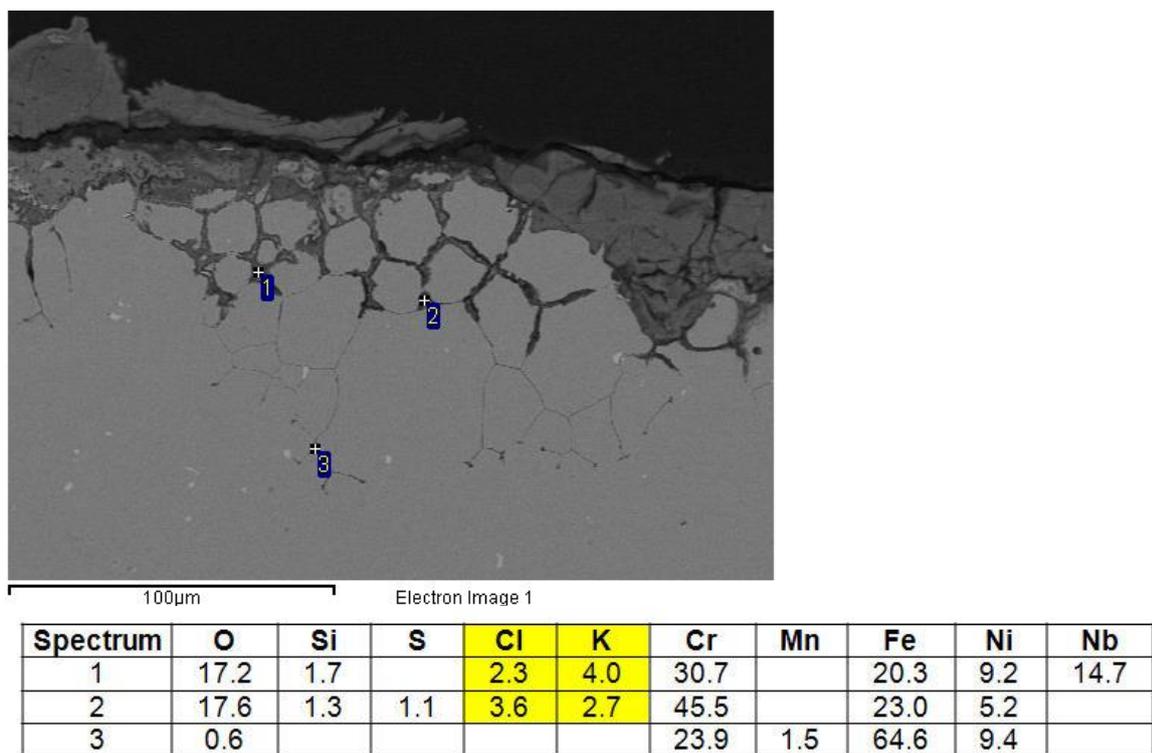
Studies at DTU of samples from steel TP347HFG tubes (18%Cr, 10%Ni) used in superheater test sections at Amagerværket unit 1 underline the influence of K on the corrosion also in real plant conditions; K can be found alongside Cl in grain boundaries at the corrosion front, see figure 3. The tubes were exposed for 5900 hours at a steam temperature of 535°C. Even under these relatively mild conditions the steel was not able to maintain a protective oxide layer and significant internal corrosion occurred.

**Figure 3.** Biomass induced corrosion on a TP347HFG steel tube from a superheater. Extensive attack along grain boundaries, K and Cl are located in the boundaries at the corrosion front; results of composition measurements at points 1-3 are shown in table 1. SEM backscatter contrast image. The table shows compositions in mass percent measured with SEM-EDX at the positions indicated.

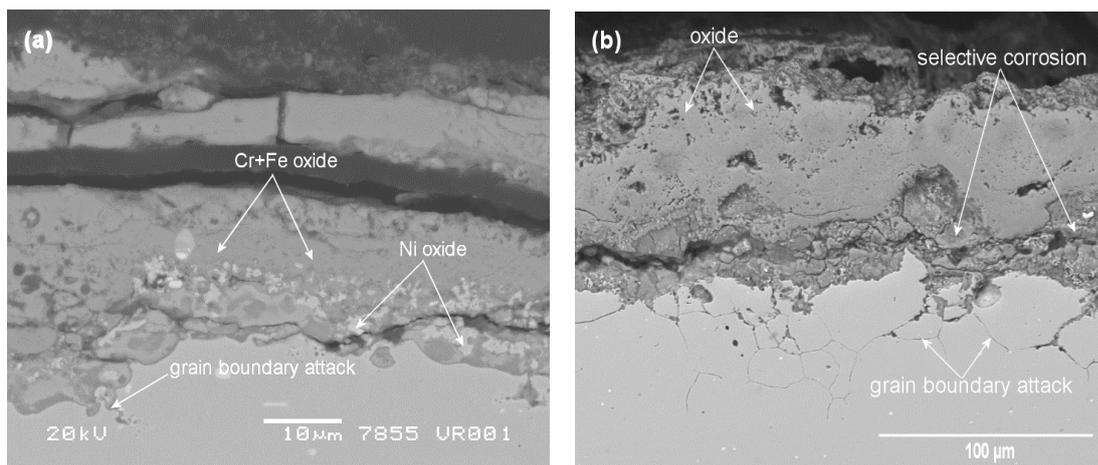
The corrosion morphology of the exposed uncoated tubes from Randers (Esshete 1250) and MSK (TP347H) after one year exposure are similar. The corrosion morphologies consist of a porous outer oxide, an inner selective corrosion area and grain boundary attack (Figure 20). The oxide located in the outermost corrosion product was rich in chromium and iron, while the oxide beneath was rich in nickel. No indications of formation of a protective chromium-rich oxide could be seen. This type of corrosion morphology is typical for chlorine induced corrosion, where volatile metal chlorides form via reaction with chlorine species. As the chlorine species are transported towards the outer surface they react with oxygen to form the porous outer oxide while the chlorine is released to again react and form new volatile metal chlorides, a chlorine corrosion cycle that is often referred to as active oxidation [2]. Because of the progression of the corrosion attack it is unclear if an initial breakdown of protective oxide scale occurred due to potassium chromate formation from a chemical reaction between chromium rich oxide and KCl as shown in laboratory studies [11, 34, 35] or whether corrosive chlorine species could enter into the steel along pores or cracks in the oxide.

**Figure 20.** Corrosion morphology on uncoated tubes after boiler exposure in (a) Randers and (b) MSK.

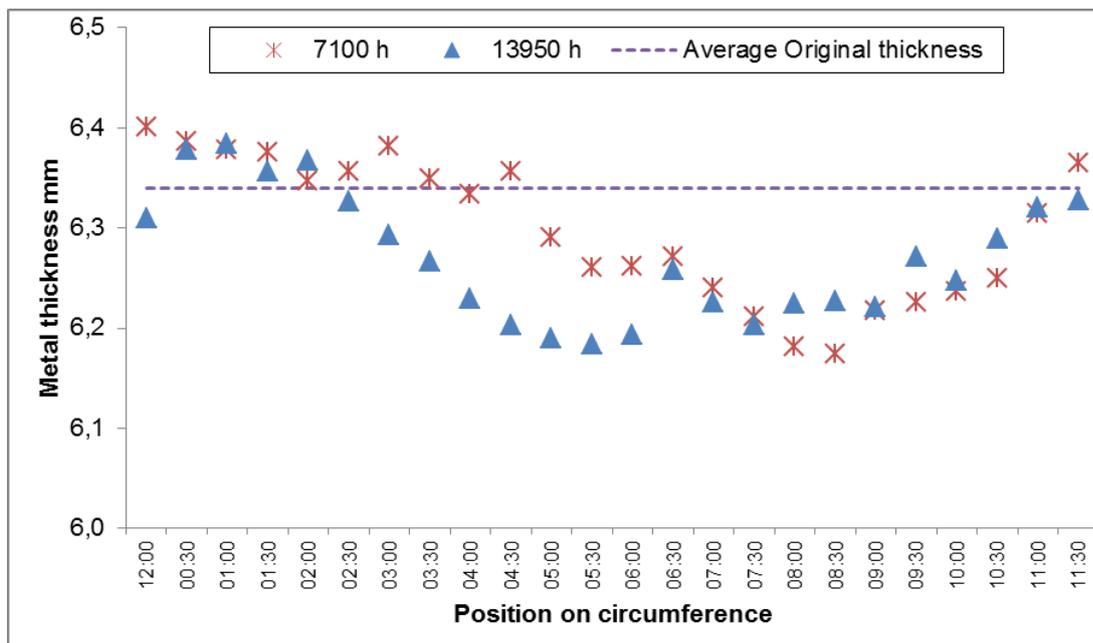
After two years exposure the metal loss of the uncoated tube from Randers was measured in 24 positions around the circumference of the tube (Figure 21). The position 12:00 marks the flue gas direction. The tubes after 2 years exposure exhibited more attack around the circumference compared to 1 year with an increased amount of grain boundary attack, but the maximum depth of attack did not increase.

**Figure 21** Residual metal thickness of Eshete 1250 after 1 and 2 years exposure in Randers (red data points from 1 year exposure).

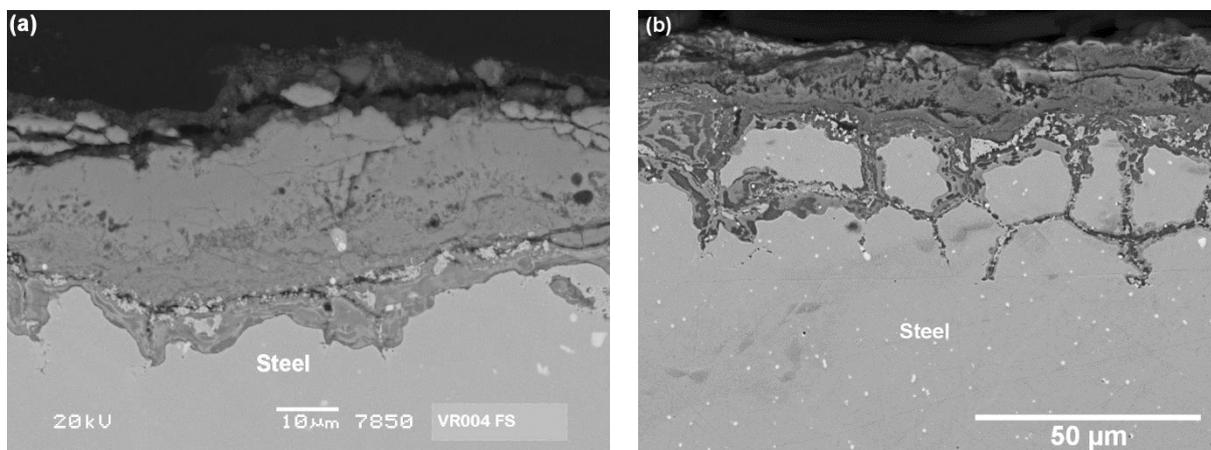
Typical cross-sectional microstructure of the uncoated reference tubes from Randers after 1 year (2015-2016) and 2 years (2015-2017) boiler exposure are presented in Figure 22. The corrosion morphologies consisted of an outer Fe rich oxide and an inner more Cr rich oxide and Cr enrichment along the grain boundaries. A greater amount of grain boundary attack was observed after 2 years exposure.

**Figure 22.** Back-scattered SEM micrographs of cross-sections of the uncoated Eshete 1250 reference tubes, (a) 1 year boiler exposure, (b) 2 years exposure.

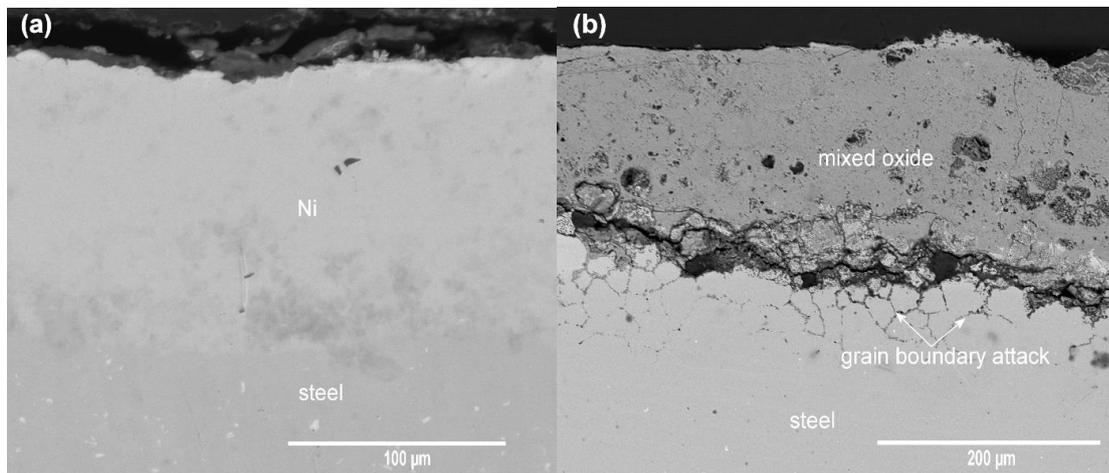
The corrosion morphology of the exposed Ni coated tubes for Randers and MSK are very different as shown in Figure 23. The Ni coated tube showed good performance after exposure in Randers where the Ni layer was still attached to the steel and no significant attack was measured. The measured metal loss is  $3.37(\pm 2.25) \mu\text{m}$  and the calculated corrosion rate for Ni is  $0.47 \mu\text{m}/1000\text{h}$ . Similar results have been observed in the laboratory. Ni revealed a significantly better performance compared to Fe-Cr-Al alloys at  $670^\circ\text{C}$  with KCl in air, but had lower performance compared to NiAl alloys [14]. When two different exposures were conducted at  $600^\circ\text{C}$  with slightly different oxidising gases and with and without KCl, a nickel oxide of  $4 \mu\text{m}$  was formed in both exposures even though the amount of KCl was much higher in one of the experiments [11]. However, for the exposure in MSK, severe attack occurred and the  $135\mu\text{m}$  Ni layer was no longer present. The corroded tube section had a mixed iron and chromium oxide at the surface and grain boundary attack into the substrate steel, which was similar to the corrosion morphology observed on the uncoated tube. It is highly probable that the slight mismatch in thermal expansion coefficients (Fig 31) gives problems where there is excessive thermal cycling at MSK. Thus cracks/channels can form that allow for the migration of corrosive species to the Ni-steel interface and the outward migration of Cr chlorides. The corrosion attack thus occurring underneath the Ni-layer will further contribute to poor adhesion between Ni-layer and steel tube.

**Figure 23.** Corrosion morphology on Ni coated tubes after boiler exposure in (a) Randers and (b) MSK

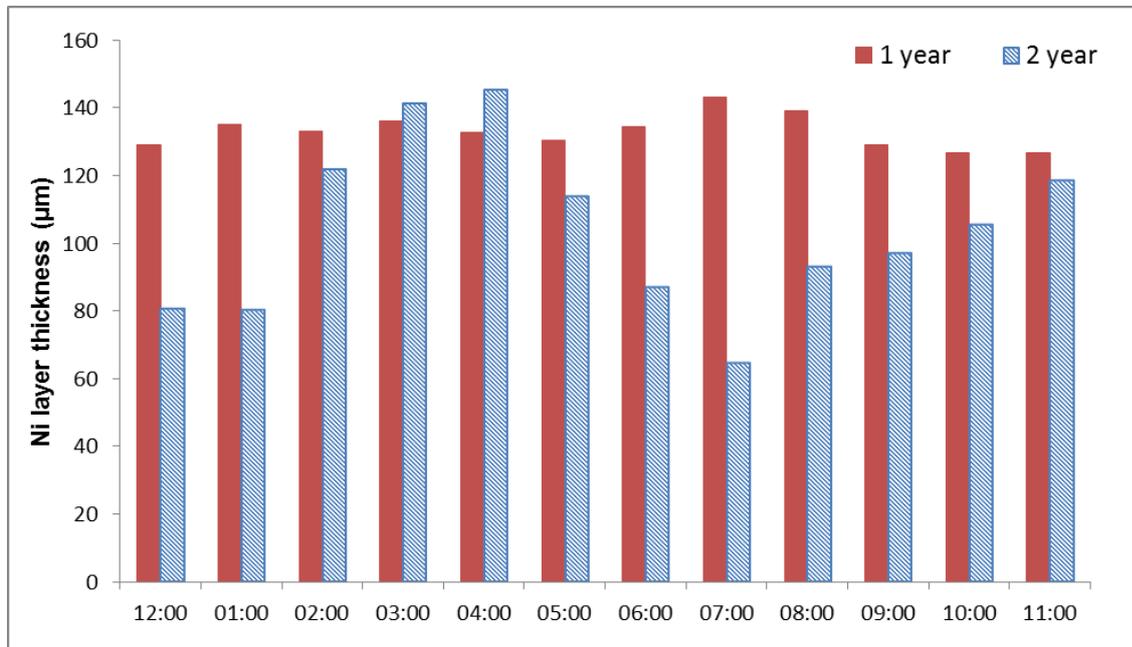
The measured nickel coating thickness at Randers at 12 positions around the circumference is shown in figure 24. Since the initial nickel layer was about  $135\mu\text{m}$ , and after the 1<sup>st</sup> year the average thickness was  $133\pm 4\mu\text{m}$ , there was minimal removal of the nickel layer, however after the second year, there was a clear decrease in thickness on the flue gas side and the leeside. The cross-sectional microstructures of the Ni coated tubes after exposure in the power plant are shown in Figure 5. Compared with the 1 year exposure, a much thicker Ni oxide had formed on the coating surface after 2 years exposure. After the second year the Ni coating was still well adherent to the underlying substrate and the substrate was apparently protected. No cracking was identified within the Ni coatings, however the presence of very small "precipitates" (at a depth shown by the double headed arrow) was observed only for the tube exposed for 2 years. These precipitates were clearly visible at higher magnifications (Figure 26).

**Figure 24:** Comparison of Ni layer thickness after exposure for 1 and 2 years at Randers.

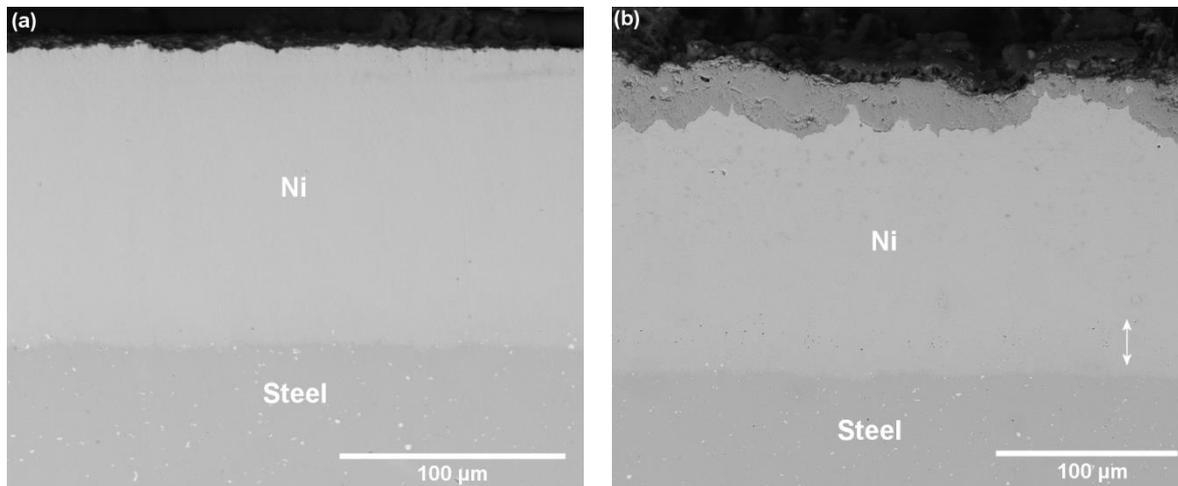
**Figure 25:** Back-scattered SEM micrographs of cross-sections of the Ni coated tubes, (a) 1 year exposure, and (b) 2 years exposure.

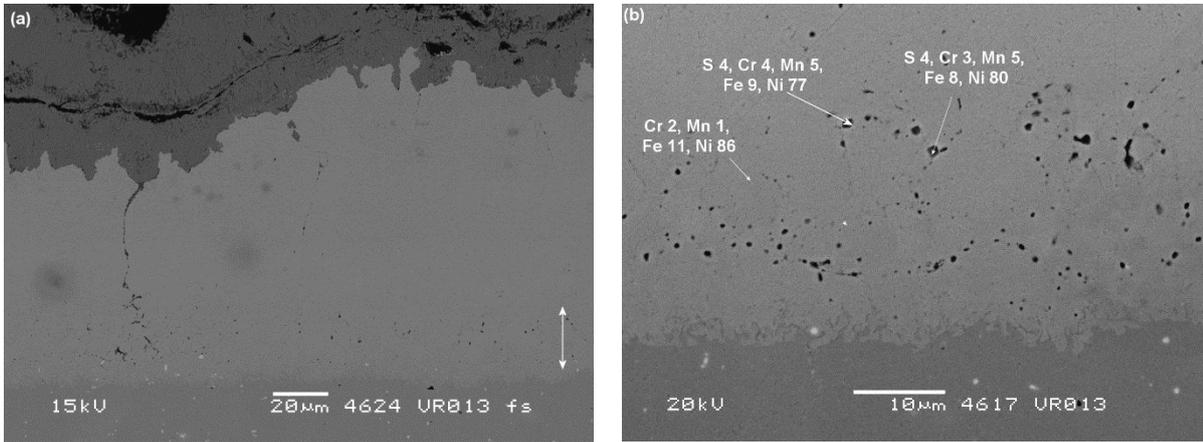
Further examination of the Ni coating near to the nickel-stainless steel interface revealed that there were enrichments of Mn and S at grain boundaries in the Ni layer shown by the arrow (Figure 26a). For the precipitates shown in Figure 26b, some of the surrounding area was also analysed due to the SEM-EDX interaction volume of the analysis, however the indication of sulphur and increased Mn was clear. The measured Mn contents were 5 wt.% which is significantly higher than the 1 wt.% Mn that was measured in the general interdiffusion area next to the precipitates. The Mn+S enrichments were always present within the nickel layer above the nickel-steel interface, probably at grain boundaries. Pathways from the nickel oxide surface through the Ni-layer could occasionally be observed; however in many cases they were not as evident as in Figure 26a. Careful re-examination of the tube cross-sections from one year exposure revealed almost no Mn and S enrichments, indicating that their formation primarily occurred during the second year.

**Figure 26:** Other areas of tube after 2 years exposure a) showing intergranular pathways from oxide and region of precipitates (white double headed arrow), b) higher magnification at the alloy-nickel interface revealing Mn+S rich precipitates with analysis in wt.%.

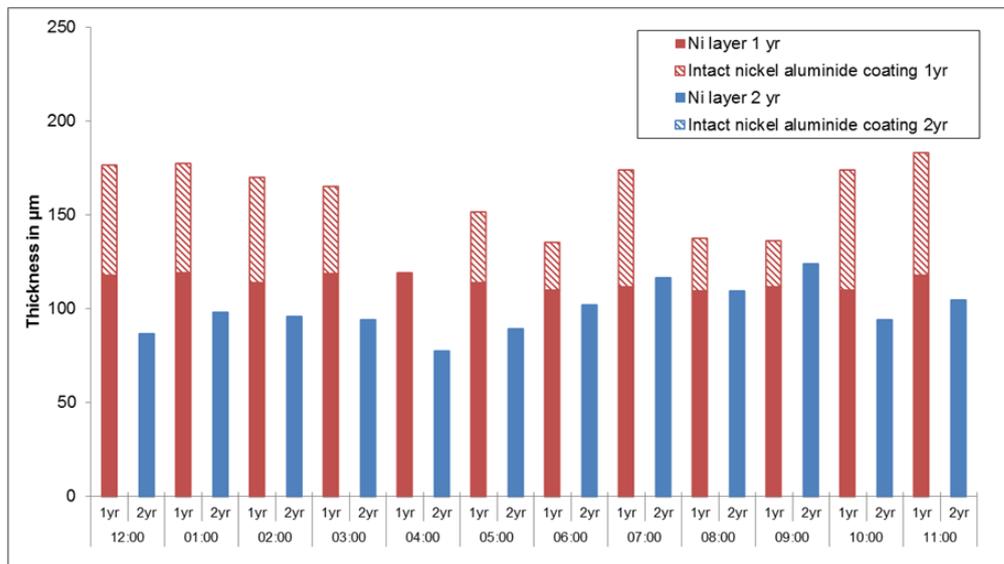
The coating thickness was measured after exposure in 12 positions clockwise around the circumference of the  $Ni_2Al_3$  coated tube as shown in Figure 27 where 12:00 is the flue gas direction. The coating thickness around the  $Ni_2Al_3$  coated tube is asymmetric. The deposit growth is typically asymmetric around a superheater tube depending on the flue gas flow conditions that vary around the tube. The attack at areas opposite the flue gas may be due to the varying deposit parameters on the upstream (12:00) compared with the downstream (06:00) part of the tube [38].

**Figure 27.** Residual thickness of layers around the circumference of the  $Ni_2Al_3$  coated tube in Randers.

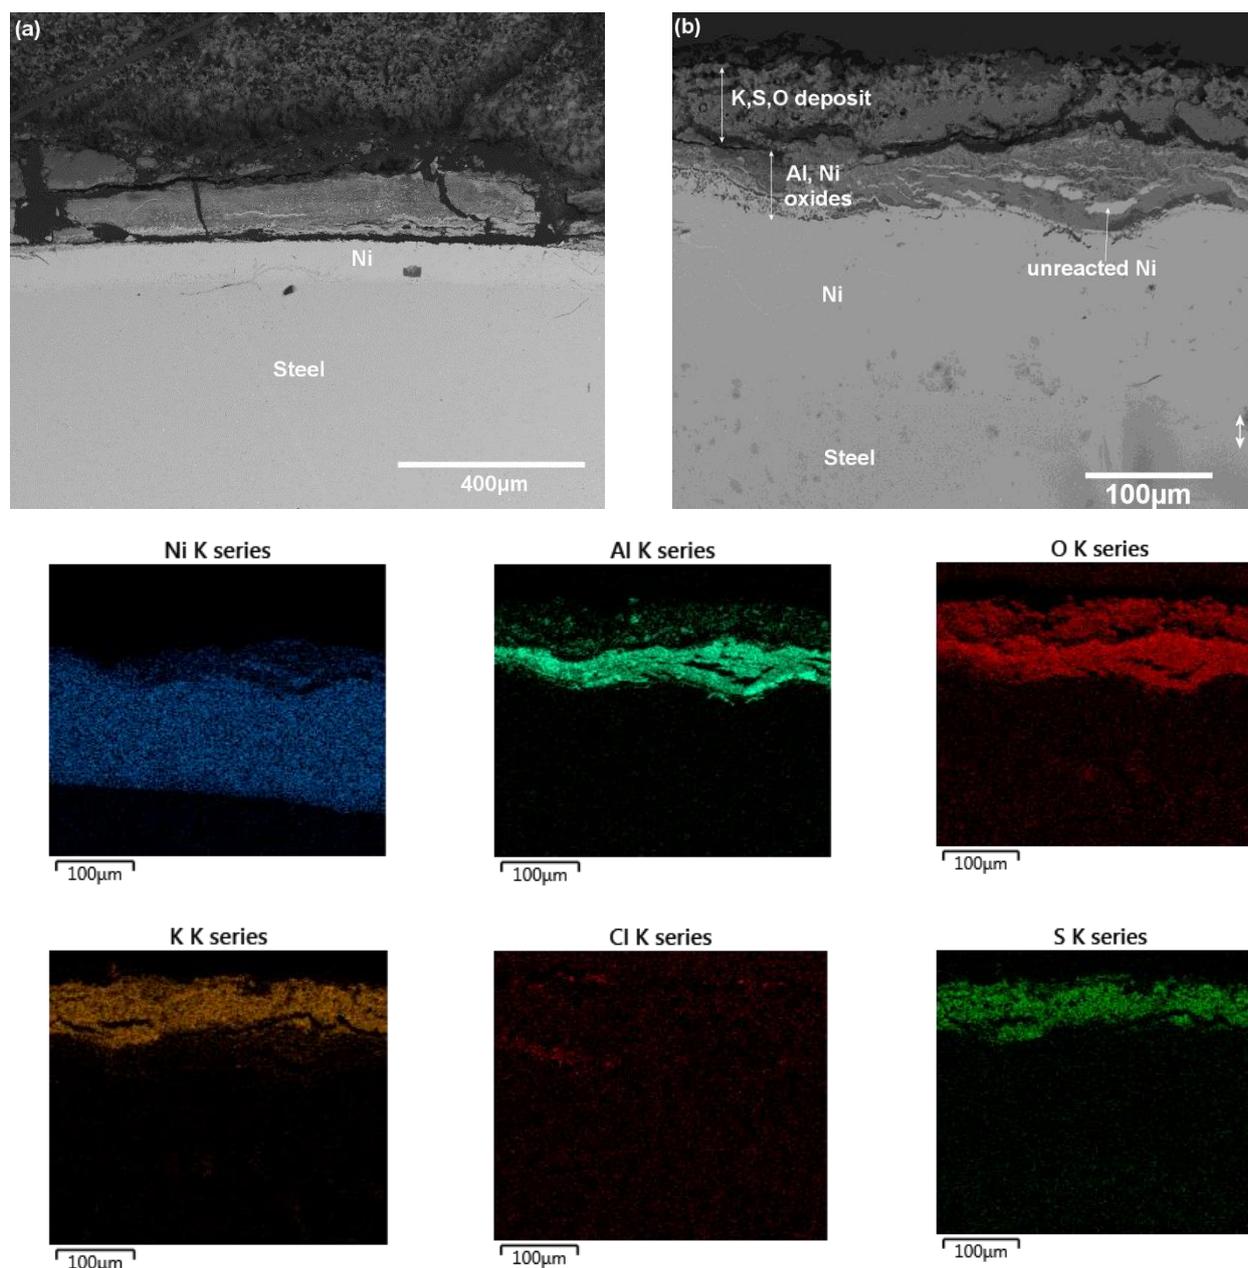
In Figure 28, the typical morphology of corrosion products observed on the nickel aluminide coated tubes after corrosion exposure in the biomass boiler for 2 years is shown. Figure 28a shows a spalled nickel aluminide coating, which corresponds to position 3:00 in figure 27. The corrosion attack had completely consumed the coating and it had then spalled at the coating-Ni interface. For most of the area around the circumference (~90%), Figure 28b is a representative micrograph where the nickel aluminide coating was attacked and where corrosion products containing aluminium were still adherent. The composition and the distribution of the corrosion products in Figure 28b is presented in the elemental distribution maps. In this area, the outer layer consisted of K, S and O, presumably  $K_2SO_4$  from the deposit, however the deposit analysis indicated that more KCl was present in other areas. Below the deposit, a porous corrosion product containing Al and Ni was identified with O and K also present within this layer. Traces of Cl were observed at the surface of the deposit probably as KCl and at the corrosion front at the left hand side of the micrograph. There were some Ni rich regions within the corrosion product which were analysed to be unreacted metallic Ni.

**Figure 28:** Back-scattered SEM micrographs of cross-sections of the nickel aluminide coated tubes after 2 years boiler exposure in Randers, (a) spallation of the nickel aluminide coating, (b) corrosion attack of the nickel aluminide coating revealed by EDS mapping.

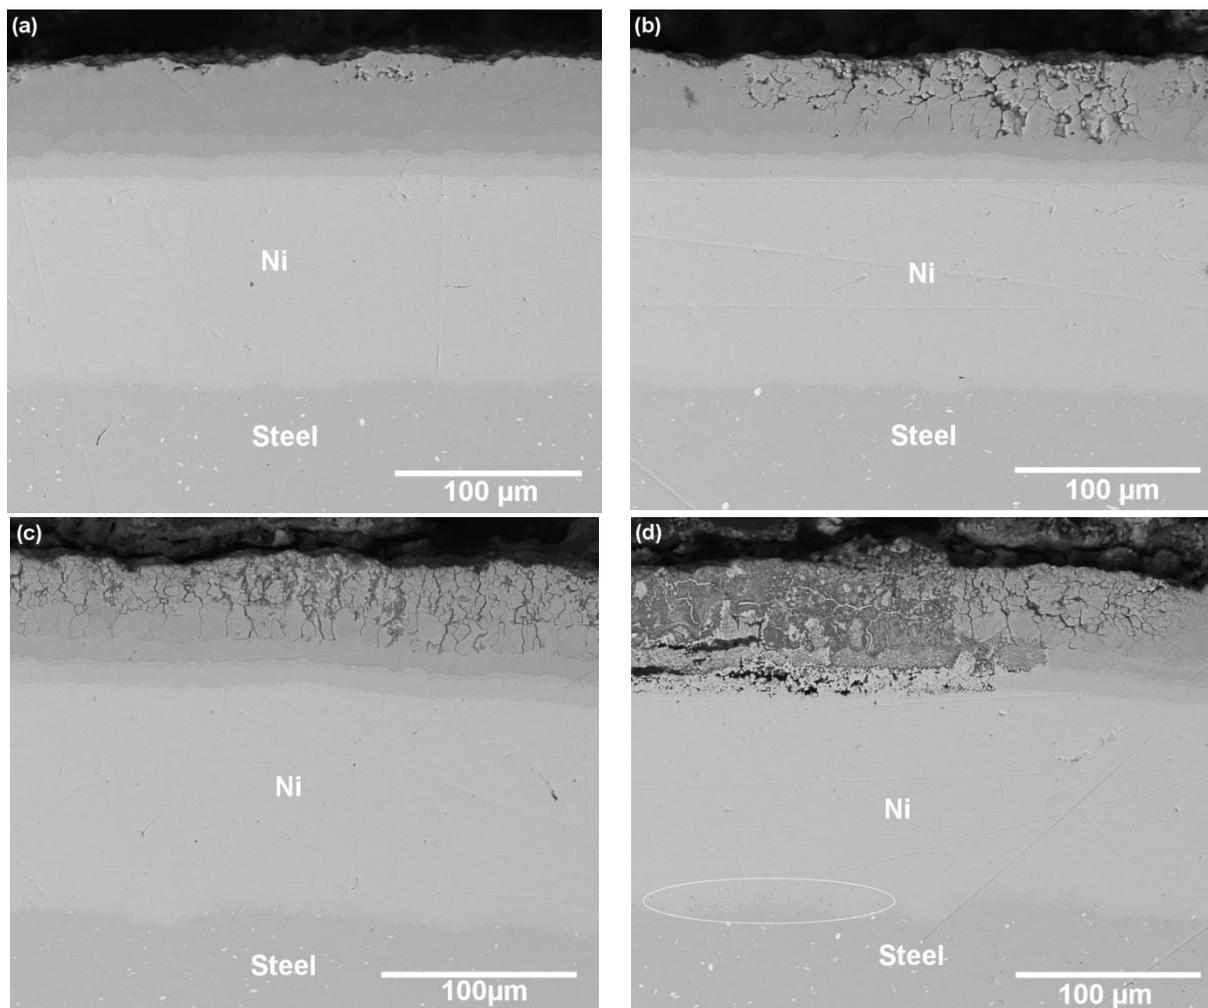
To understand the degradation leading to the complete failure of the nickel aluminide coating after the second year, different stages of local corrosion attack of the nickel aluminide coating after the first year were studied in detail with SEM. Figure 29 shows localized areas after the first exposure year with different degrees of attack ranging from very limited attack in Figure 29a to descaling of the coating shown in Figure 29d. At most locations the nickel aluminide coating exhibited the behavior shown in Figure 29a with only slight surface attack, which corresponds to the positions on the tube circumference from 10-3 o'clock and at 7 o'clock. In the positions shown in Figure 29b-d the coating was attacked and aluminium depletion of the coating was visible. The worst case location corresponding to the 4o'clock position is shown in Figure 29d, where the nickel aluminide coating reached end of life, and the underlying Ni layer was being attacked. At all locations, the underlying steel was still well protected without sign of corrosion attack.

**Figure 29:** Back-scattered SEM micrographs of cross-sections of the  $Ni_2Al_3$  coated tubes showing different corrosion stages after 1 year boiler exposure, (a) protective surface, (b) Al depletion and porosity formation, (c) porosity and corrosion propagation, (d) penetration attack and coating spallation (white ellipse showing position of internal precipitation).

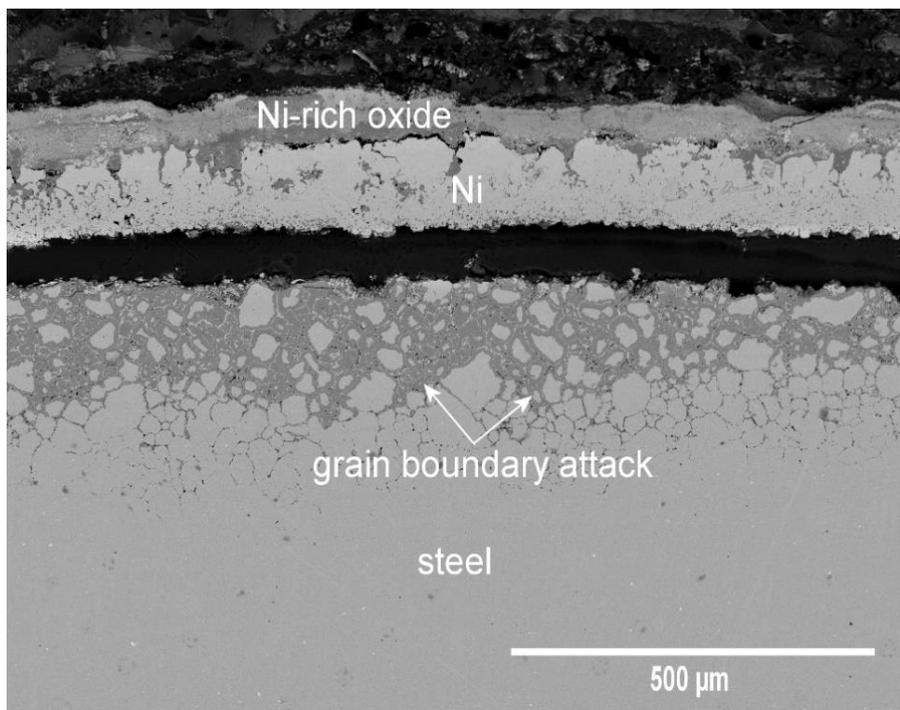
Compared with the exposure in Randers, the  $\text{Ni}_2\text{Al}_3$  coated tube performed much worse in MSK. As shown in Figure 30, the nickel aluminide layer was no longer adherent to the tube; this was the case around the whole tube circumference. The spalled nickel aluminide coating could be found within the deposit, and investigations showed that in the spalled section some Al depletion had occurred but there was still alumina. Remnants of an oxidized nickel layer (up to 70  $\mu\text{m}$ ) were present in approximately two-thirds of the circumference of the tube sample with varying depths of attack of the underlying tube. This indicates that the  $\text{Ni}_2\text{Al}_3$  layer offered some initial protection before spalling off, since there was no Ni left on the tube coated only with Ni (cf. Fig. 23b). The presence of a  $\text{Ni}_2\text{Al}_3$  coating hinders evaporation of metal chlorides from the corrosion front, but does not prevent Cl species diffusing to the corrosion front. Beneath the Ni layer, the formation of trapped nickel chloride also hampered the corrosion process by binding the aggressive chlorine.

**Figure 30.** BSE image of corrosion morphology for the  $\text{Ni}_2\text{Al}_3$  coated tube after boiler exposure in MSK

Since there are many thermal cycles at MSK (Figure 9), the most probable explanation for the spallation of the  $\text{Ni}_2\text{Al}_3$  coating lies in the difference in thermal expansion coefficients between the steel, Ni, Ni-Al intermetallics forming at the interface and the  $\text{Ni}_2\text{Al}_3$ . The coefficients of thermal expansion (CTE) for the steels, Ni, NiAl and  $\text{Ni}_2\text{Al}_3$  are depicted in Figure 24. For the power plant exposure temperature interval between 300°C and 600°C the CTE for  $\text{Ni}_2\text{Al}_3$  differs significantly from the CTE for Ni, NiAl and steels. A full stress analysis is outside of the scope of the present work, however, as the CTE for  $\text{Ni}_2\text{Al}_3$  and Ni are quite different, thermal stresses could be expected which would lead to the spallation of the  $\text{Ni}_2\text{Al}_3$  coating in MSK. The spallation of Ni from the steel was probably related to the corrosion attack of the underlying steel which led to a weak adhesion between Ni and steel.
