# Final report

<b>Project title</b>	<b>New Coatings for Biomass Firing</b>
<b>Project identification</b>	14-I 64014-0109
<b>Name of the programme which has funded the project</b>	EUDP 14-I. Programme area: Biomass
<b>Project managing company/institution</b>	DTU Mekanik, Niels Koppels Allé 404, 2800 Kgs. Lyngby
<b>Project partners</b>	Added Values P/S Refa Energi A/S Verdo A/S Burmeister & Wain Energi A/S – replaced by BWSC A/S
<b>CVR</b> (central business register)	30060946
<b>Date for submission</b>	November 13, 2018

*The project aimed to develop and demonstrate new corrosion resistant coating materials for heat exchangers (superheaters) in biomass fired CHP plants. Very promising systematic laboratory results had indicated that coatings based on Al and/or Ni could to enable improved economy in biomass firing through increased reliability, prolonged lifetimes and higher efficiency.*

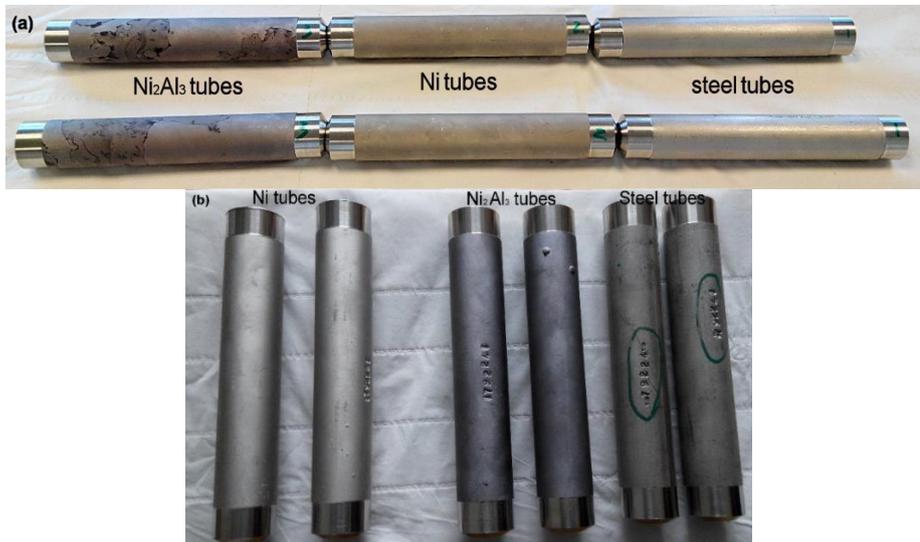
For aluminizing several experiments with optimization of the coating process were performed at DTU [27], which led to the following process parameters: The Ni coated tube sections were embedded in a pre-mixed pack powder (10 wt. % Al + 8 wt. % AlCl<sub>3</sub> + 82 wt. % Al<sub>2</sub>O<sub>3</sub>), which was put into a cylindrical metal crucible. The crucible was then placed in the tube furnace with flowing argon. The furnace was heated to 650°C with a heating rate of 18°C/min, and maintained at this temperature for 6 h. The samples were afterwards cooled inside the furnace by switching off the power while maintaining the argon flow. After aluminizing, the Ni<sub>2</sub>Al<sub>3</sub> coated tubes were ultrasonically degreased in acetone and subsequently dried with ethanol. The coating was removed by machining from a 2 cm wide area from both ends of the Ni<sub>2</sub>Al<sub>3</sub> coated tubes prior to welding. The tubes after preparation are shown in Figure 7. The discoloration area on the Ni<sub>2</sub>Al<sub>3</sub> tubes (Figure 7a) is due to a thin (around 2 μm) Al<sub>2</sub>O<sub>3</sub> layer, which was probably related to surface oxidation during furnace cooling or the last part of the pack aluminizing process. Destructive examination from similar locations revealed that the Ni<sub>2</sub>Al<sub>3</sub> coating beneath the thin layer was intact and uniform. The bubbles visible on Ni and Ni<sub>2</sub>Al<sub>3</sub> tubes (Figure 7b) were probably due to hydrogen gas introduced during the Ni-plating process.

**Figure 7.** Appearance of the first set of test tubes for (a) Esshete 1250 and (b) TP347H.

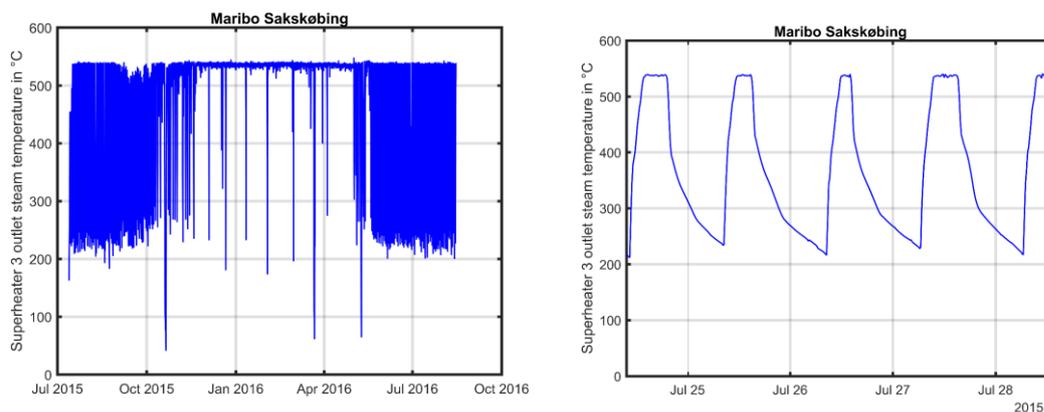
However, at MSK the plant is run under cyclic conditions with daily start/stops in the beginning and end of the heating season (Figure 9). This means that at MSK the boiler runs at full load when in operation. This difference in operating conditions can also be seen when comparing the temperature histograms, which is broad for the Randers plant, and narrow for the MSK plant (Figure 10).

**Figure 9.** The outlet steam temperature data for MSK, showing the whole exposure period (left) and the daily cycle (right).

The temperature data during the exposure period from Randers and MSK (Figures 8-10) show significant differences. The average test tube steam outlet temperature in Randers was 512 °C, while in MSK it was 544 °C. The significantly higher average steam temperature at MSK than at Randers would obviously increase the degree of fireside corrosion. Randers also has a broader temperature range with a significant amount of hours below 500°C where there would be minimal corrosion for an austenitic steel. As has been previously observed for these types of steels, corrosion increases significantly with increase in temperature [49] and this is probably the main reason for the higher corrosion rates of the steel tubes observed for the MSK plant. Another important factor is the thermal cycling of the plants. The plant in Randers has only had one shutdown during the entire exposure period and otherwise the operation temperature has been relative stable. This is in complete contrast to the MSK plant where frequent thermal cycling resulted in severe exposure conditions. At the MSK plant there has been three full shutdowns, but during autumn and late spring, there was thermal cycling every day between 200 and 540 °C (Figure 9) resulting in 213 start/stop cycles (Table 3). This is with high certainty the reason behind the spallation of both Ni and  $Ni_2Al_3$  coatings in the MSK boiler.

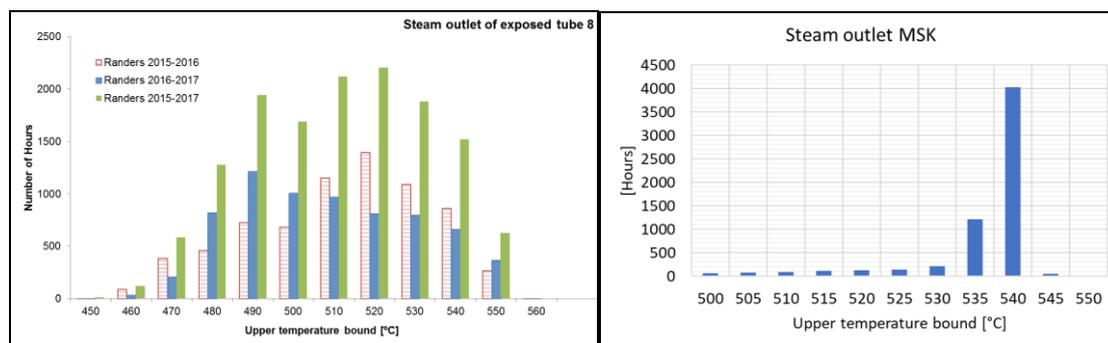
**Figure 10.** Temperature histograms for the whole exposure period for Randers (left) and for the first year for MSK (right)

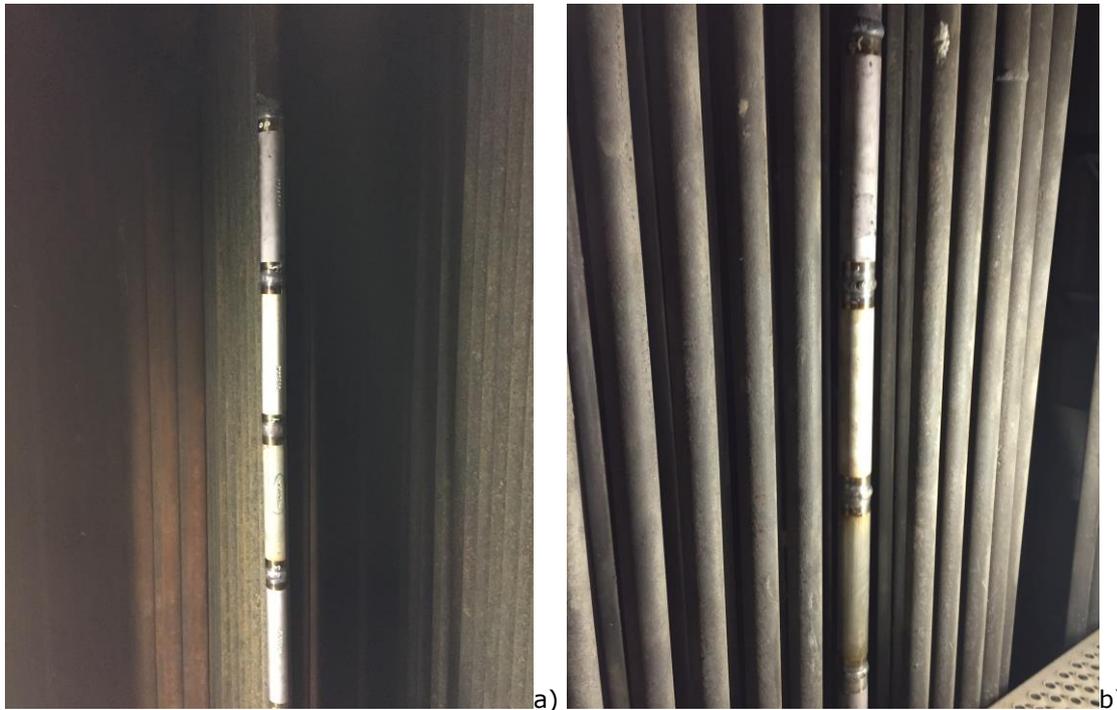
After the test installation had been approved by the pressure vessel authorities (Arbejdstilsynet) the tubes were welded into the superheaters at the selected positions. Figure 15 shows the installed tubes.

**Figure 15.** Test tubes welded into the superheaters at a) MSK and b) Randers.

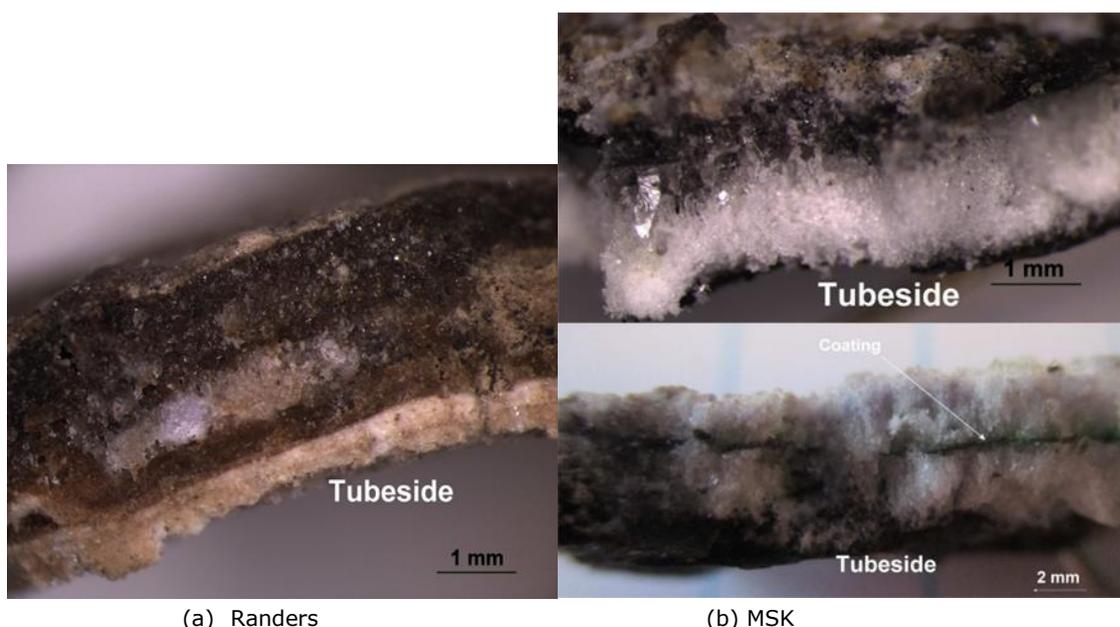
The deposits were removed from the exposed tubes and examined with SEM-EDX. The deposit from Randers was sintered to the tube and a scalpel was required for removal whilst the deposit from MSK was fragile and easily flaked off. Photographs of the deposits are shown in Figure 17. The deposit from Randers was more compact with different layers where a whitish layer was present adjacent the tube. When the deposit was removed from the tube, almost no oxide was adherent. The deposit from MSK consisted of white crystals adherent to the underlying oxide and on the coated tube. Some of the coating was also present within the deposit.

(a) Randers

(b) MSK

**Figure 17.** Appearance of deposits removed from the exposed tubes.

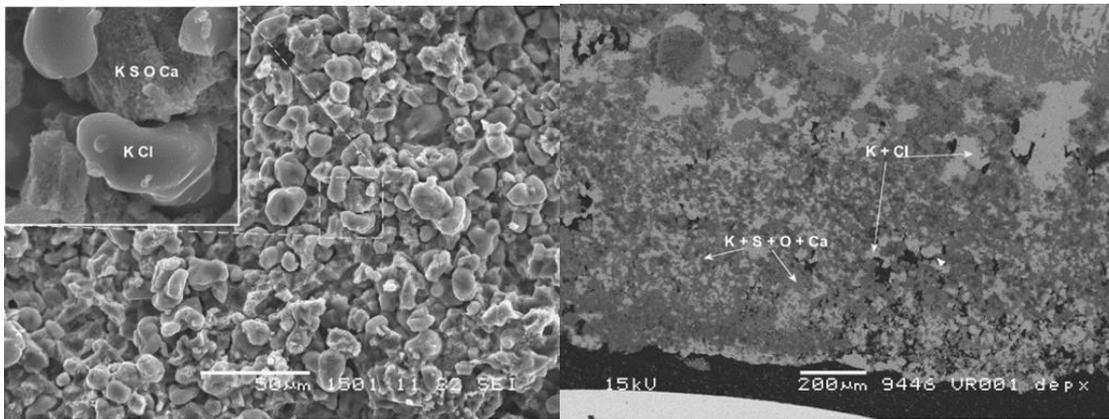
The surface morphology and composition of the deposit close to the tube was investigated using SEM-EDX on both deposit flakes and cross-sectioned deposits. For deposit from Randers, the analysis of the underside of the deposit revealed two different morphologies (Figure 18a), a smooth morphology, which was probably KCl as the measured mole ratio for K/Cl was 1:1, and small particles that were presumably sulphates of potassium and calcium. Analysis of the dry polished cross-sections of the deposit also detected K, S, Ca and O and K, Cl rich regions (Figure 18b). These elements were present throughout the deposit; however there were more Si rich fly ash particles on the outer part of the deposit.

(a) Deposit adjacent the tube (b) Cross section of the deposit  
**Figure 18.** Surface morphology and composition of deposit from Randers

The high K and Cl content in the deposit adjacent the tube at MSK and Randers is due to the fuel used which was rich in potassium and chlorine. Since only small amounts of potassium sulphate were present adjacent the deposit at MSK, this would indicate that the sulphation process of KCl only has a partial contribution to the corrosion attack compared to Randers. In laboratory experiments, Okoro et al. [33] measured similar extents of internal corrosion attack for specimens in an oxidizing environment ( $\text{CO}_2 + \text{H}_2\text{O} + \text{O}_2$ ) with and without  $\text{SO}_2 + \text{HCl}$ , as long as KCl was present. The different morphologies of the KCl deposits may be linked to the tube temperature difference, which is lower at Randers than at MSK. Bröstrom et al. [34] investigated condensation of KCl and showed that above  $500^\circ\text{C}$ , facetted KCl crystals were formed similar to Fig. 19a whereas at lower temperatures, a more dendritic appearance was apparent. They suggested that vapor is cooled by thermal condition from the metal tube, and then outward growth occurs by direction condensation of vapor phase to result in this structure.

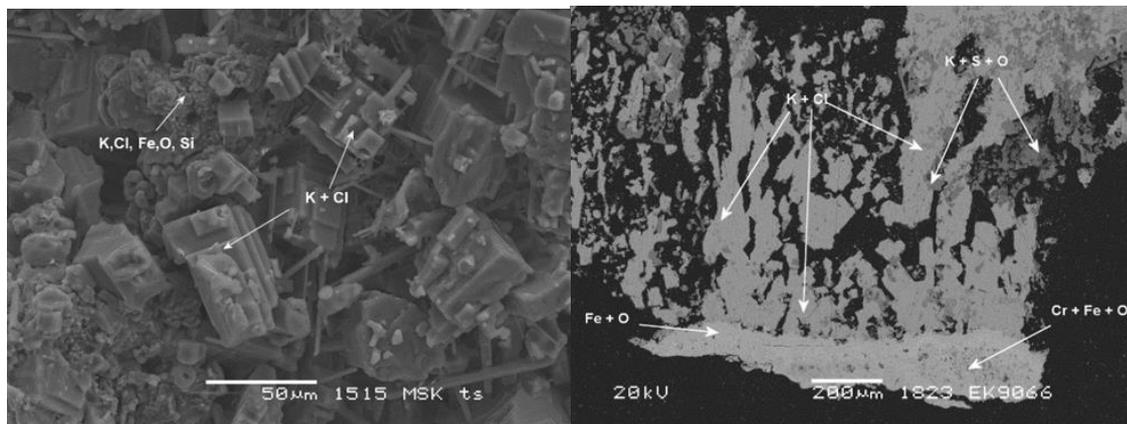
Facetted cubic structures were typical on the unprepared deposit from MSK (Figure 19a), where the cubic structures had a composition corresponding to KCl. The KCl was in direct contact with the surface oxide and there were remnants of iron oxides on the surface. Cross sections of the dry polished deposit also showed that KCl is present adjacent to the oxide surface and there was only occasionally K, S, and O (presumably potassium sulphate) present (Figure 19b).

(a) Deposit adjacent the tube (b) Cross section of the deposit  
**Figure 19.** Surface morphology and composition of deposit from MSK.

At MSK, there were many thermal cycles and this could contribute to repeated spallation of the deposit resulting in new deposit forming on the tube. In contrast, the more sintered deposit from Randers may be more protective against incoming corrosive species. It could be suggested that after the initially formed KCl is exhausted, corrosion would decrease, as it would be more difficult for KCl to advance to the surface of the tube resulting in corrosion. Lindberg et al. [35] describes the behavior of a deposit due to a thermal gradient, revealing how deposit can be vaporized from the flue gas-deposit surface, and species can be trans-

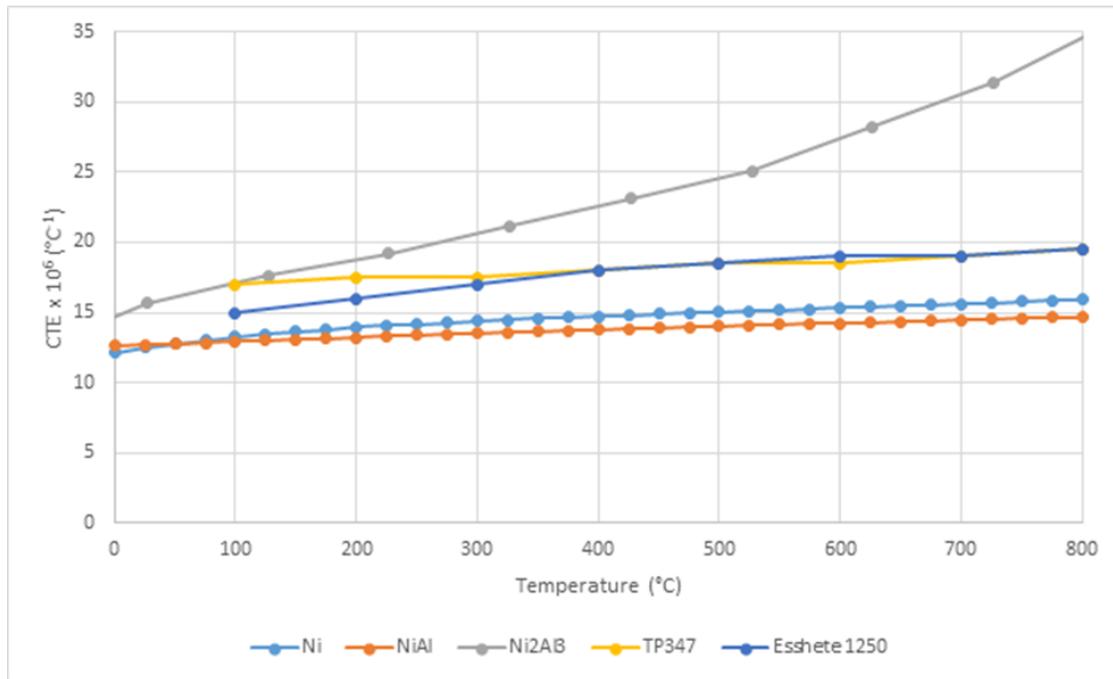
Since there are many thermal cycles at MSK (Figure 9), the most probable explanation for the spallation of the  $\text{Ni}_2\text{Al}_3$  coating lies in the difference in thermal expansion coefficients between the steel, Ni, Ni-Al intermetallics forming at the interface and the  $\text{Ni}_2\text{Al}_3$ . The coefficients of thermal expansion (CTE) for the steels, Ni, NiAl and  $\text{Ni}_2\text{Al}_3$  are depicted in Figure 24. For the power plant exposure temperature interval between 300°C and 600°C the CTE for  $\text{Ni}_2\text{Al}_3$  differs significantly from the CTE for Ni, NiAl and steels. A full stress analysis is outside of the scope of the present work, however, as the CTE for  $\text{Ni}_2\text{Al}_3$  and Ni are quite different, thermal stresses could be expected which would lead to the spallation of the  $\text{Ni}_2\text{Al}_3$  coating in MSK. The spallation of Ni from the steel was probably related to the corrosion attack of the underlying steel which led to a weak adhesion between Ni and steel.

**Figure 31.** The variation of CTE with temperature of pure Ni, NiAl, Ni<sub>2</sub>Al<sub>3</sub>, TP347H and Esshete 1250 [40,41]
